Manhole Inspection Summary

Manhole # S21I__019MH

Insp Date: **9/21/07 7:27 AM**

Location Address: **1817 ADDISON ST**

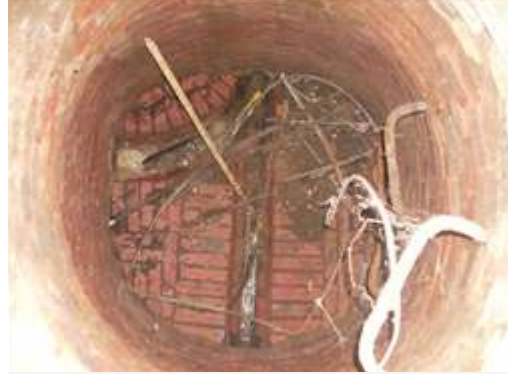
Top View

DEBRIS ON BENCH AND IN CHANNEL

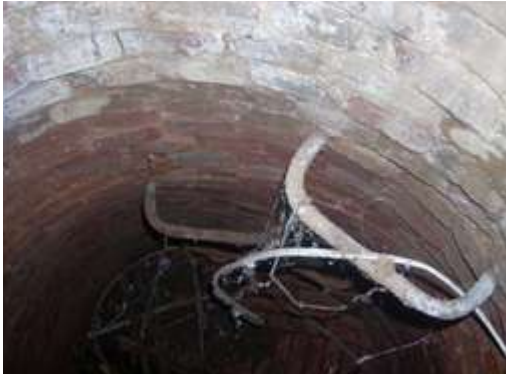
Defect 4

Steps Count: **4** Missing: **0** ☒ **Corroded**

CORRODED STEPS

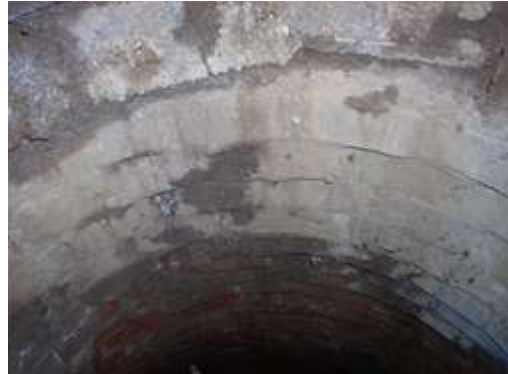
Defect 3

Infiltration: ☐ None ☐ Joint ☐ Cracks ☐ Mortar ☐ Roots ☒ **Wall**

INFILTRATION OF THE CORBEL WALL

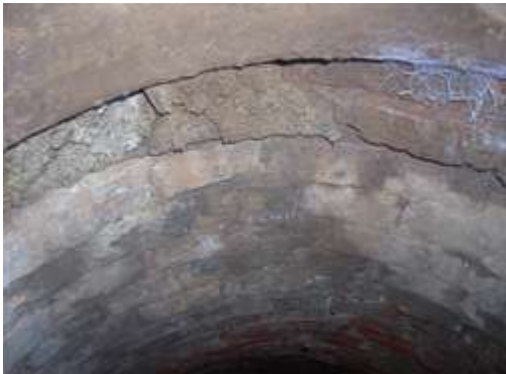
Defect 2

Condition: ☐ Sound ☐ Cracked ☐ Root Intrusion ☐ Loose Brick ☒ **Deteriorated**

Infiltration: ☐ None ☒ **Joint** ☐ Cracks ☐ Mortar ☐ Roots ☐ Wall

DETERIORATED CHIMNEY WITH
INFILTRATION EVIDENCE

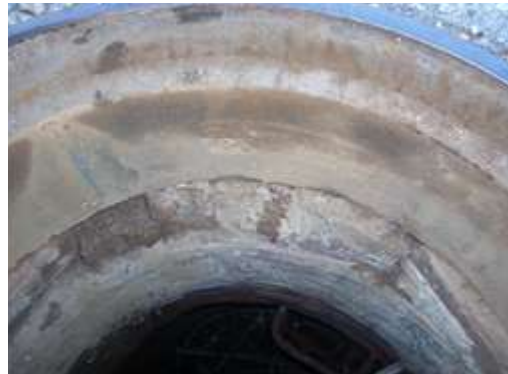
Defect 1

Frame Offset: **2** (in.) Condition: ☒ Sound ☐ Cracked ☐ Leaks

FRAME OFFSET

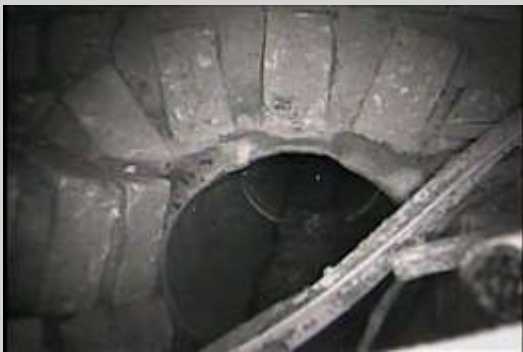
12 O'Clock Outflow

Pipe Height: **8.4** (in.) Rod and Bar (Angled)
Pipe Material: **Clay** ☐ Pipe Lined
Invert Depth: **8.92** (ft.) Flow Characteristics: **Slow**
Deposits: ☒ None ☐ Mud ☐ Sludge ☐ **Debris** ☐ Grease
Silt Depth: (in.) Deposits Extent:
Infiltration: **None** Pipe Seal Cond: **Broken**

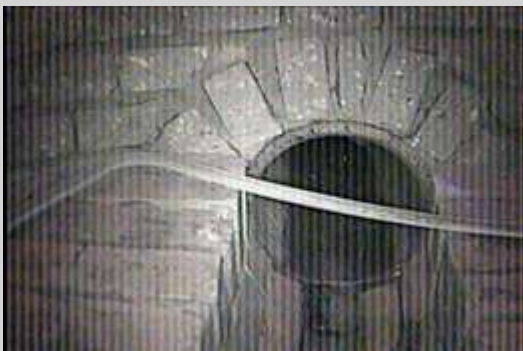
6 O'Clock Inflow

Pipe Height: **7.2** (in.) Rod and Bar (Angled)
Pipe Material: **Clay** ☐ Pipe Lined
Invert Depth: **8.37** (ft.) Flow Characteristics: **None**
Deposits: ☒ None ☐ Mud ☐ Sludge ☐ **Debris** ☐ Grease
Silt Depth: (in.) Deposits Extent:
Infiltration: **None** Pipe Seal Cond: **Sound**

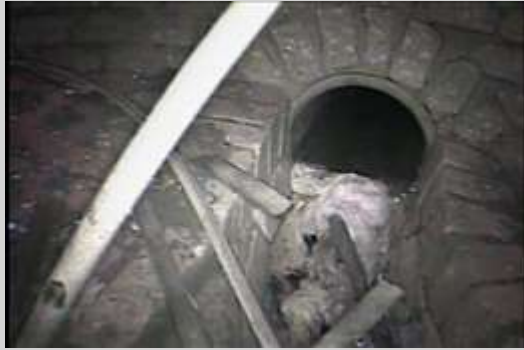
9 O'Clock Inflow

Deposits: ☐ None ☐ Mud ☐ Sludge ☒ **Debris** ☐ Grease

Silt Depth: **2** (in.) Deposits Extent: **Medium**
